ATSB TRANSPORT SAFETY INVESTIGATION REPORT
Aviation Safety Research and Analysis B02005/0055
Final

Wire-strike Accidents in General Aviation: Data Analysis 1994 to 2004

June 2006

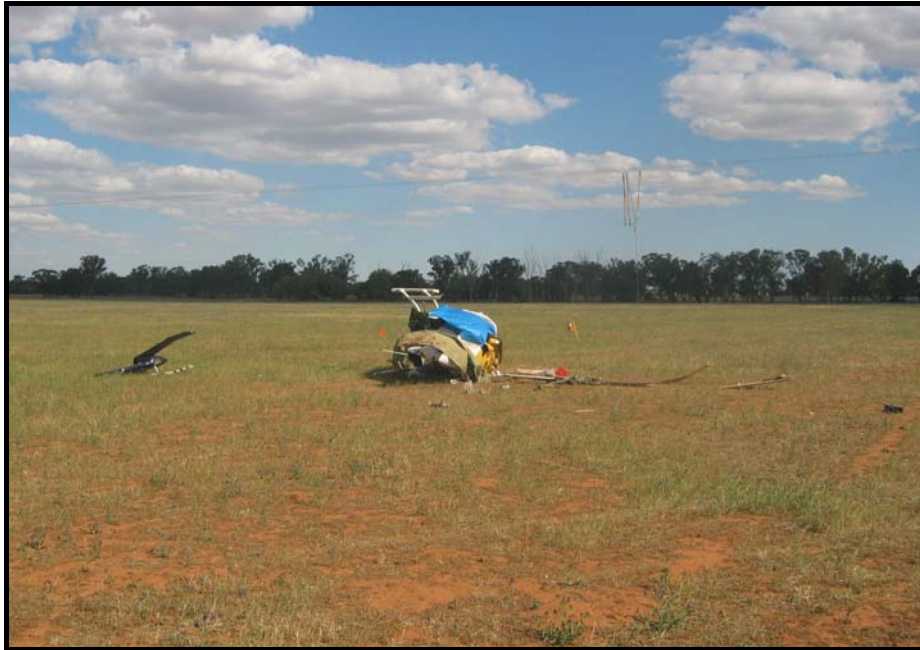
Figure 1. Bell 206B helicopter after striking powerlines during a locust control campaign near Forbes on 31 October 2004

- An accident involving a Bell 206B helicopter conducting aerial work near Forbes, New South Wales on 31 October 2004 in support of the Forbes area locust control campaign. The accident resulted in minor injuries to one passenger and extensive damage to the helicopter (ATSB Report: 200404285). The aircraft is pictured in figure 1.

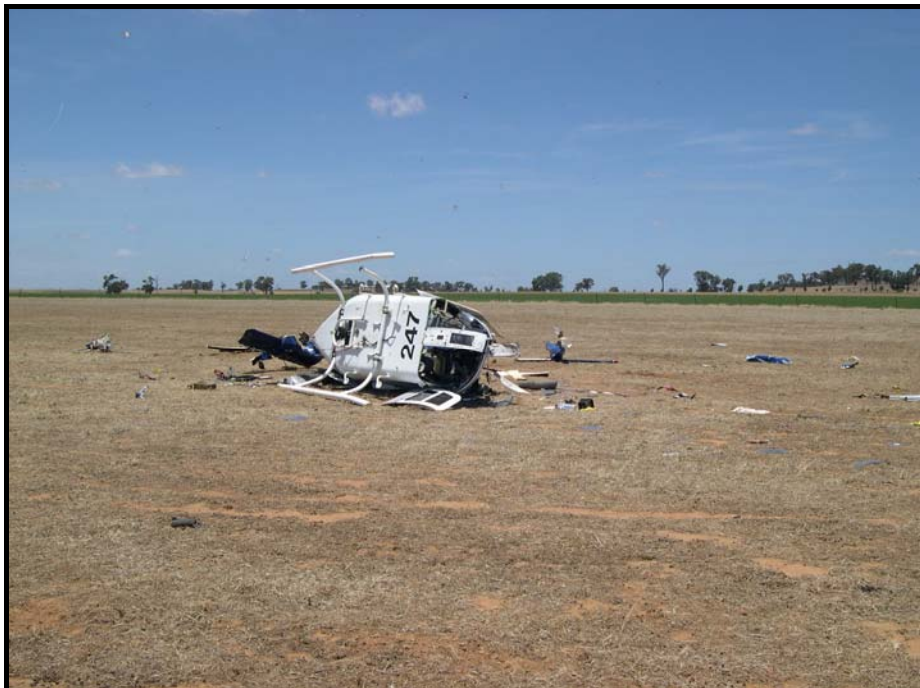
Figure 2. Bell 206B helicopter after striking powerlines during a locust control campaign near Dunedoo on 22 November 2004

- An accident involving a Bell 206B helicopter near Dunedoo, New South Wales on 22 November 2004 in support of the Dubbo area locust control campaign. The accident resulted in fatal injuries to the pilot and one passenger, serious injuries to another passenger, and extensive damage to the helicopter. (ATSB Report: 200404590). The aircraft is pictured in figure 2.

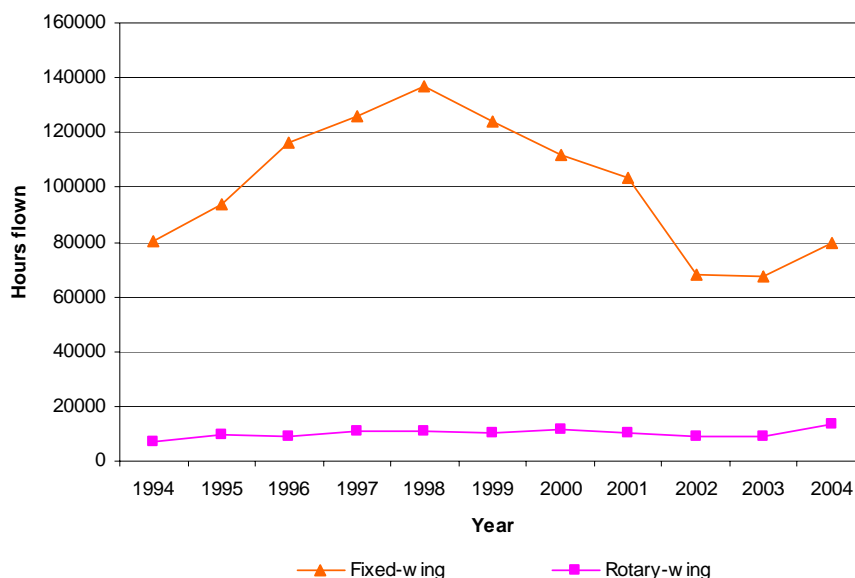
Figure 8. Hours flown in aerial agriculture operations, 1994 to 2004

Figure 8 shows the hours flown in fixed-wing and rotary-wing aircraft for aerial agriculture operations between 1994 and 2004. During this period, 92 per cent of all aerial agriculture operations were performed in fixed-wing aircraft. The remaining eight per cent were performed in rotary-wing aircraft.

The average yearly flying hours for 1994 to 2001 was 110,600 hours. This number dropped to around 70,000 hours during the drought of 2002 and 2003. A slight recovery was experienced in hours flown for both fixed-wing and rotary-wing aircraft in 2004, to just over 93,000 hours in total.

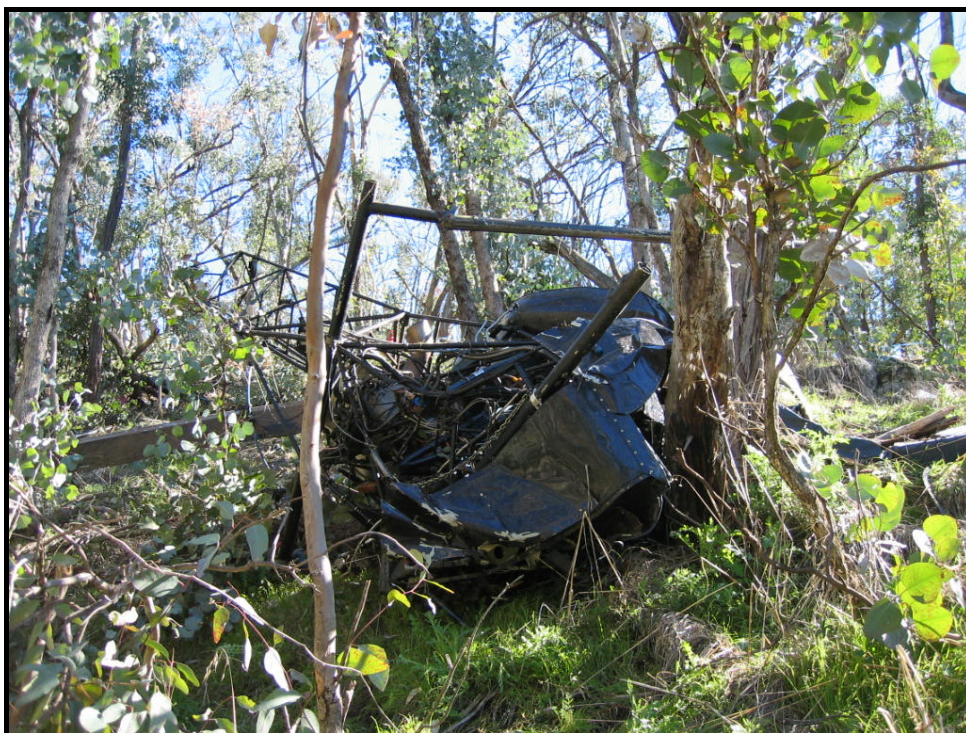
Figure 9. Bell 47G-3B-1 Soloy helicopter after striking powerlines near Wodonga on 19 June 2004

Figure 9 shows the devastating consequences of an accident involving a Bell 47G-3B-1 Soloy¹² helicopter near Wodonga in Victoria that occurred on 19 June 2004. The pilot was the sole occupant and was fatally injured. The operator of the aircraft was contracted to spray herbicide on a property in Victoria, where it collided with powerlines 12 km west of Wodonga. The powerlines ‘... consisted of two parallel three-strand lightweight high-tensile steel cables, each of 2.75 mm diameter.’ A photo of the damaged wires is presented in figure 10. The powerlines were located on the north-eastern side of a ridgeline, strung across a direct track from the spray area to the replenishment truck (figure 11). The full investigation report is available on the ATSB website (ATSB Report: 200402669).

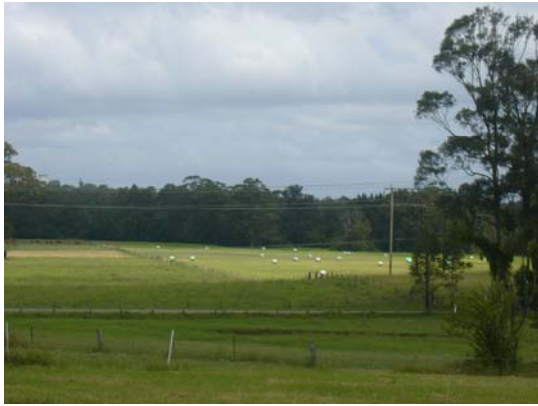
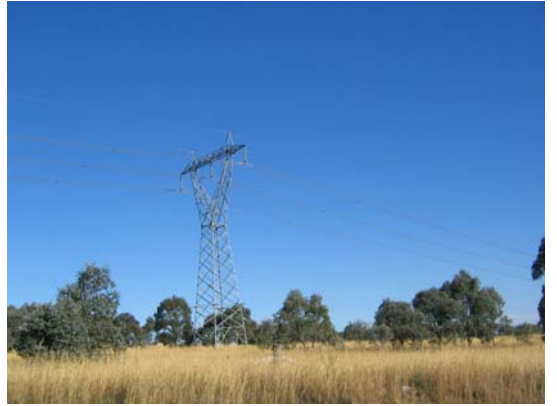
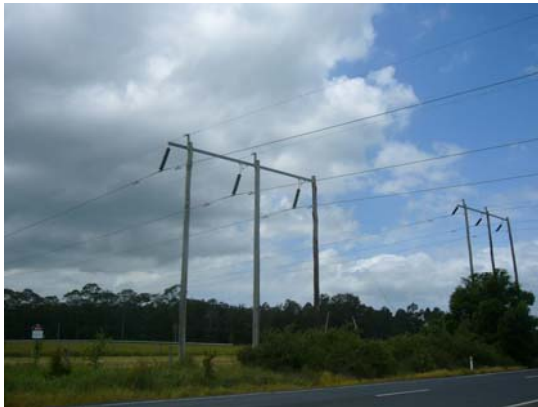
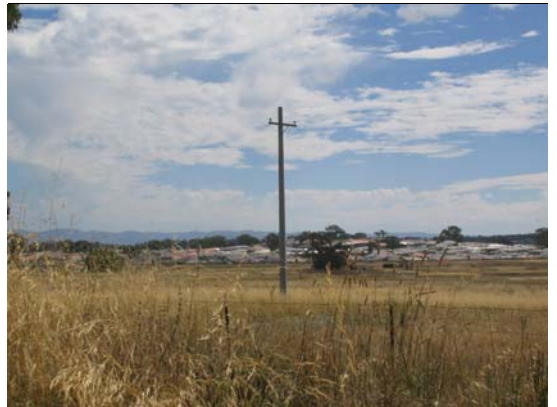
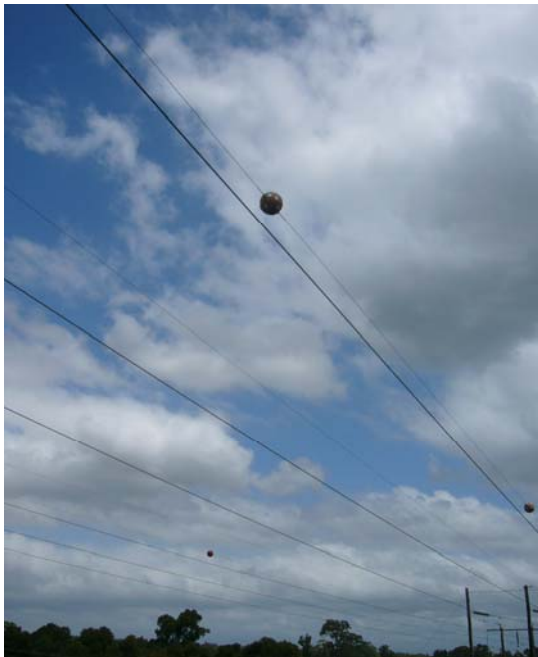
Figure 12 to 17. Examples of powerline arrangements in New South Wales

Powerlines have various configurations that range from multiple clusters of high voltage wires carried on large lattice type towers, to a single wire earth return (SWER) system. The former are high tensile heavy gauge wires that may be found at heights in excess of 100 feet AGL. Figures 12 to 17 show examples of various powerline arrangements in New South Wales.

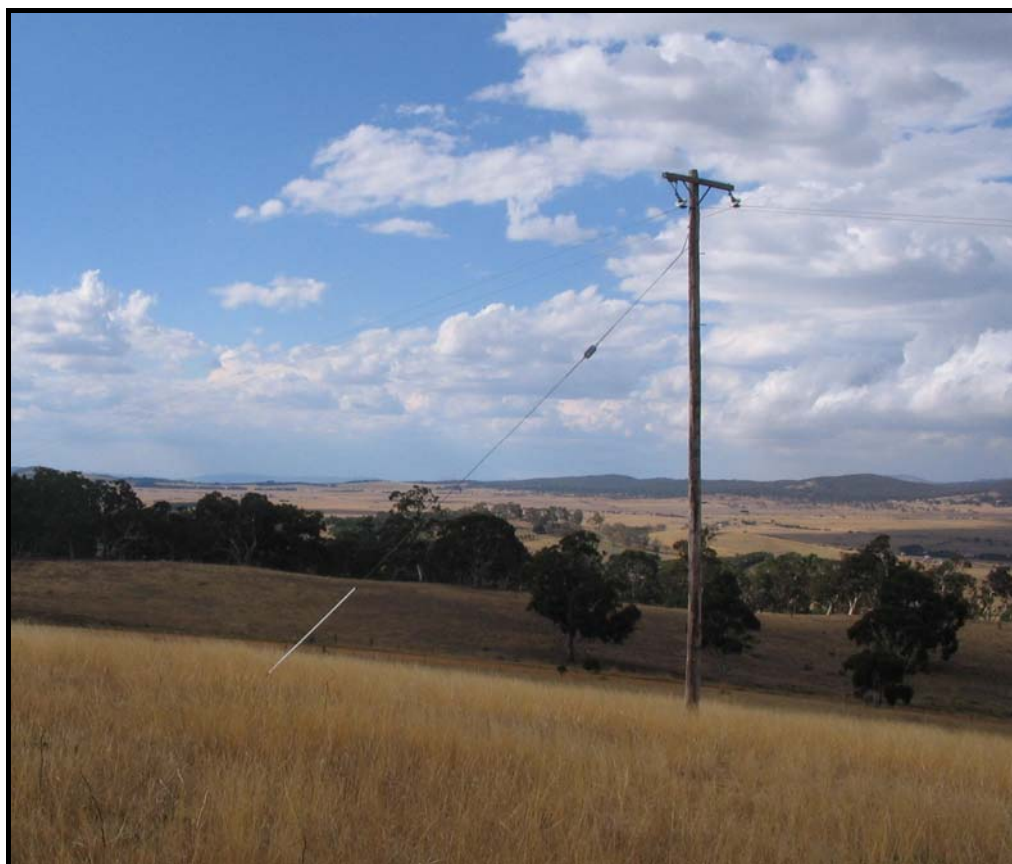
Figure 18. Example of a guy wire

Guy wires¹³ can also be difficult for pilots to see, even when the location of the wire is known. As shown in figure 18, guy wires are generally located at either the end of a wire run or on a bend in the run to counterbalance the pull of the wires.

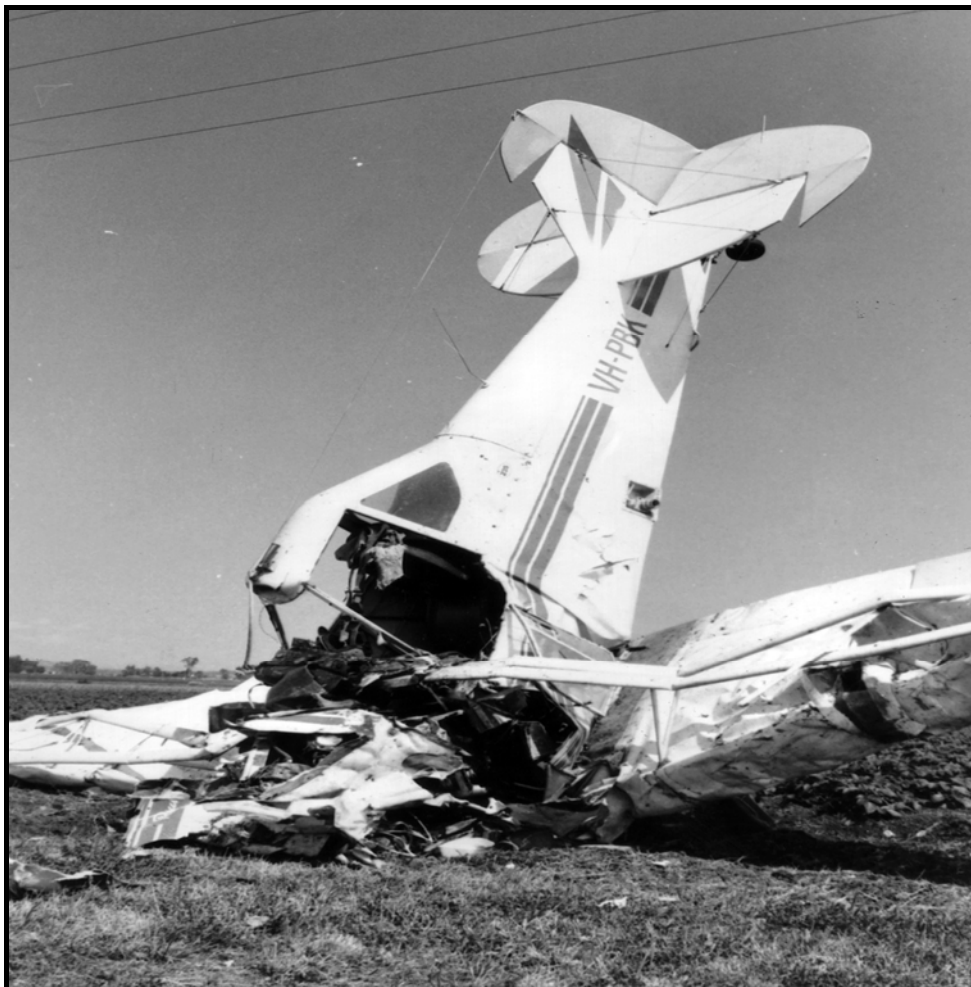
Figure 21. Aircraft after striking a high tension powerline during a pull-up manoeuvre

Figure 21 shows the devastating impact of a wire-strike on a Piper PA-25-235 aircraft when it struck powerlines during a pull-up from the first of three spray runs. The accident occurred 23 km North West of Amberley in Queensland resulting in serious injuries to the pilot, the sole occupant. Although the pilot was aware of the powerlines, having sprayed in the area before, his attention had been diverted elsewhere (ATSB Report: 198200054).

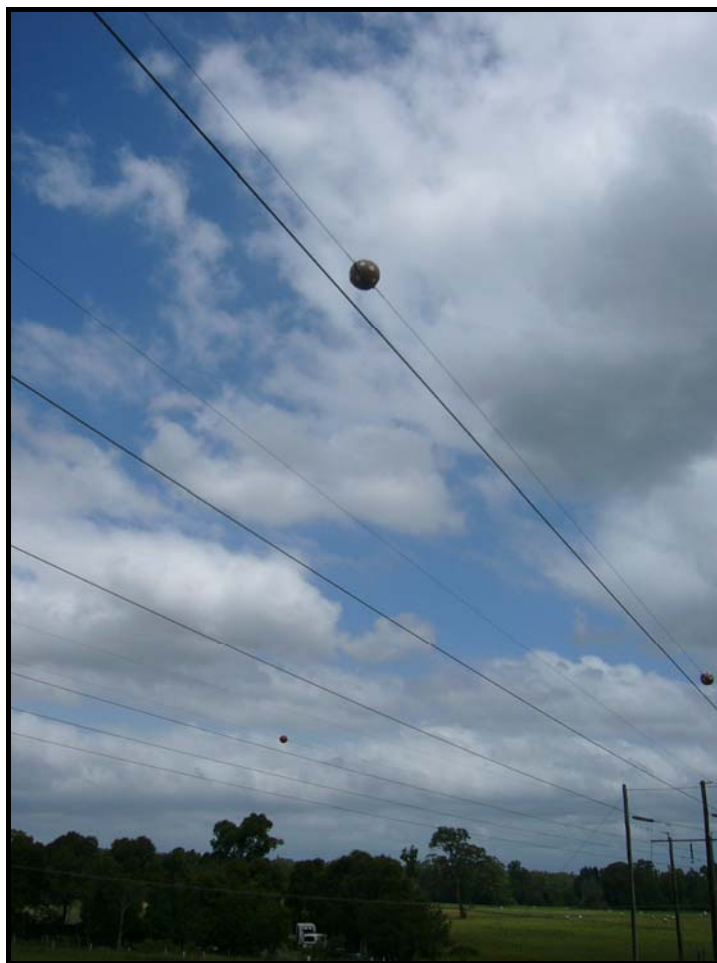
Figure 23. Example of wire markers mounted on a multi-strand powerline

Wire markers can be white, yellow, red or orange, and may be spheres, warning lights, marker panels or over-crossing markers in accordance with Standards Australia. The markers shown in figures 22 and 23 are red spheres.

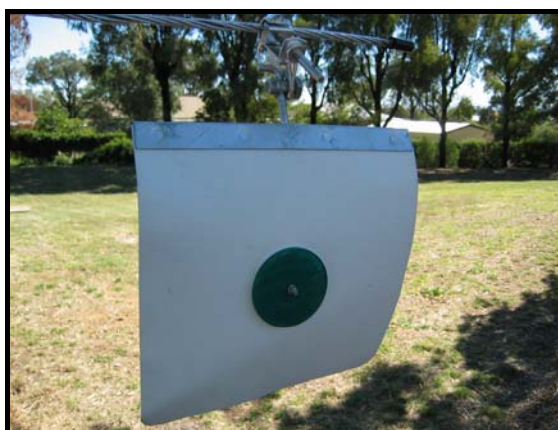
Figure 24. Example of a 'flag marker' used for aerial operations

More recently, Country Energy (New South Wales) has developed a cost effective powerline 'flag marker' to be used in areas such as crop spraying and harvesting, temporary or non-licensed aircraft landing areas, temporary air bases for fire fighting operations and external construction sites. As shown in figures 24 and 25, the marker is a mud flap shaped marker with a green retro reflector. The marker is designed to clip onto a range of conductors to increase visibility (A. Burman, personal communication, June 5, 2006).

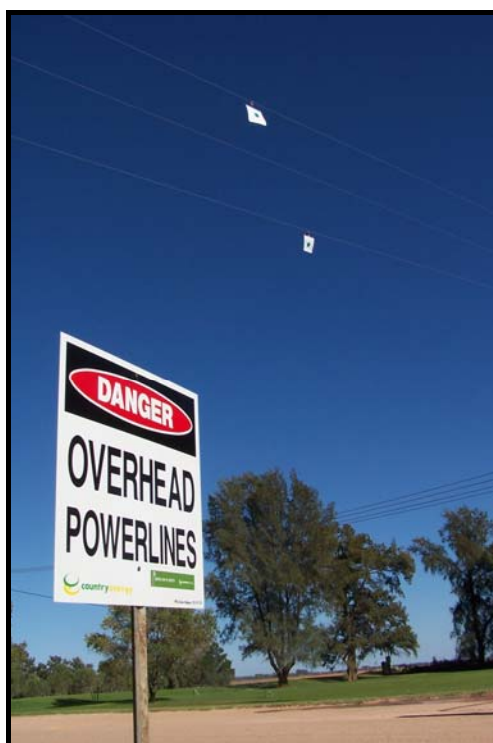
Figure 25. Example of a 'flag marker' used on overhead powerlines
